## Your Hex Metal Problems STOP Here!

By using our SpeedHex® Solutions

# Discover our SpeedHex® Solutions

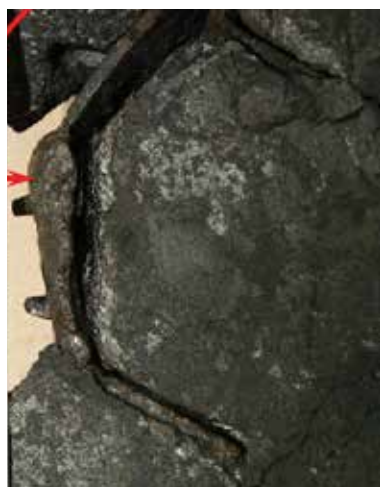
### Gas Bypass

Gaps inherent in hex metal design combined with refractory shrinkage, lead to direct pathways to the shell.

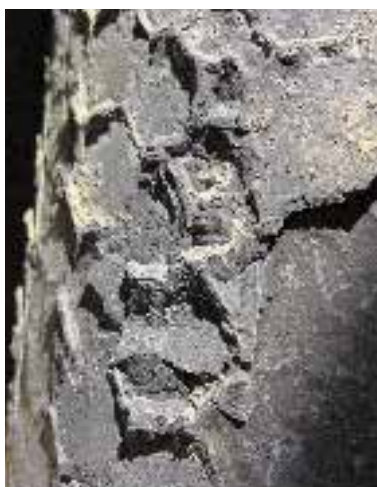
### Corrosion

Due to prolonged exposure to catalyst and process gases, hex becomes sensitized and will lead to stress corrosion cracking.

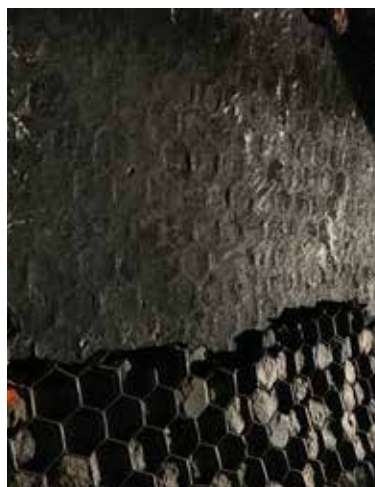
### Biscuiting

Compacted cells of refractory get pushed and squeezed, and over time, start breaking off biscuits at the hot-face.

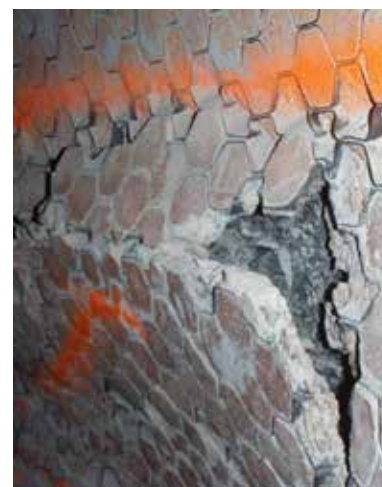
### Sheet Spalling

When welds fail due to bypass and stress cracking, sheets of hex will break and spall.

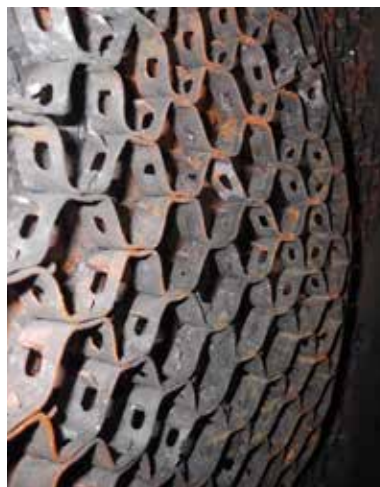
### Bulging

Bulging is caused by inherent stresses in hex, and causes localized hotspots and turbulence

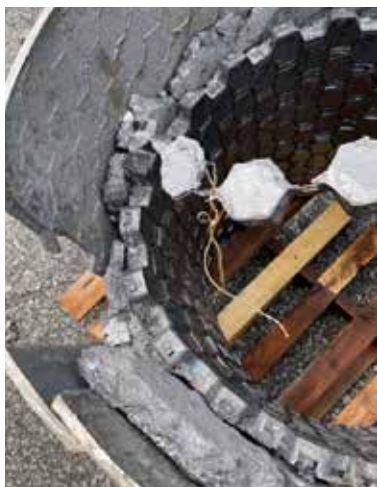
### Coke Jacking

Once coke gets behind and builds up, it forces the lining away from the wall.

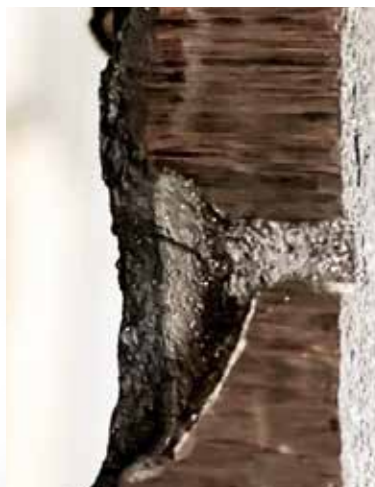
### Carburization

Exposure to bypassed gases will cause carburization and lead to structural degradation.

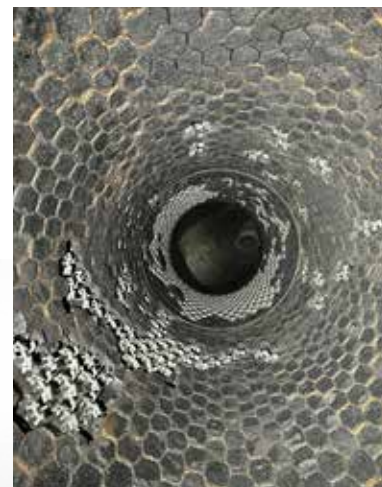
### Poor Repairability

Hex metal is notoriously hard to repair and allows for a heavily contaminated shell surface.

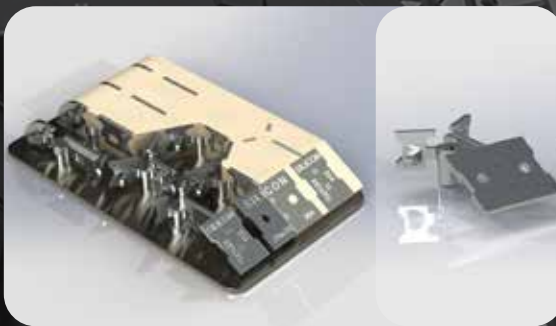
SpeedHex Refractory Termination

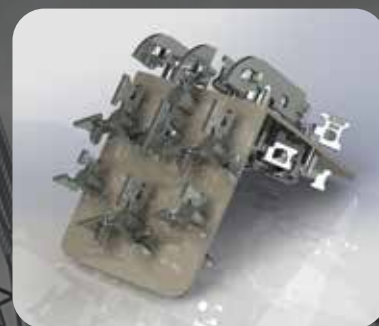
SpeedTab® on 90° Corners

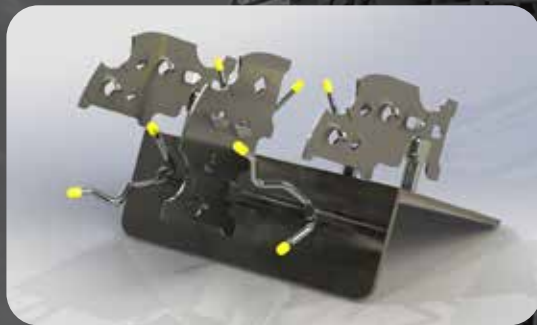
SpeedVee® & SpeedTab Mega on Corners

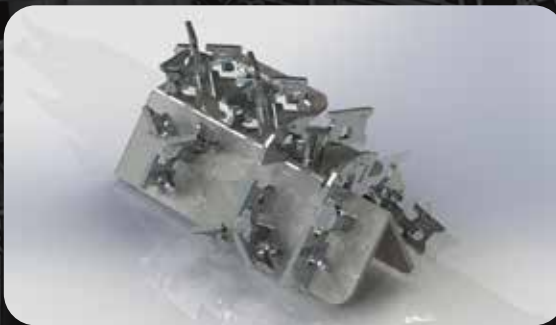
SpeedTab & SpeedHex on Varying Bullnose

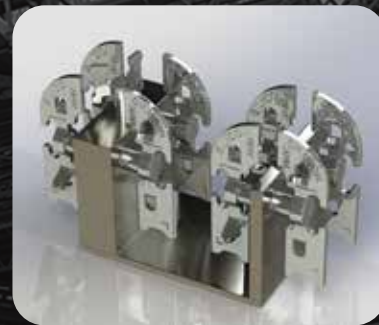
SpeedTab on Pipe Edges
