Your Hex Metal Problems STOP Here!

By using our SpeedHex® Solutions

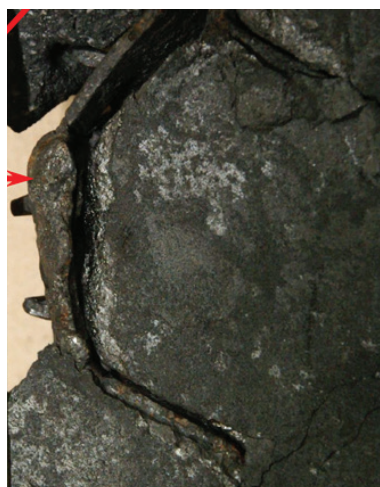
Gas Bypass

Gaps inherent in hex metal design combined with refractory shrinkage, lead to direct pathways to the shell.

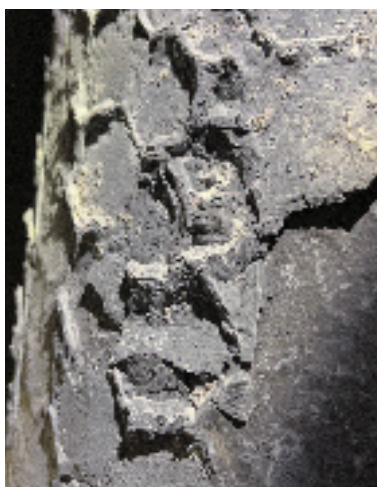
Corrosion

Due to prolonged exposure to catalyst and process gases, hex becomes sensitized and will lead to stress corrosion cracking.

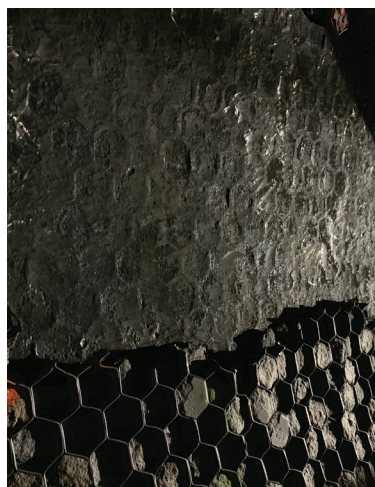
Biscuiting

Compacted cells of refractory get pushed and squeezed, and over time, start breaking off into biscuits at the hot-face.

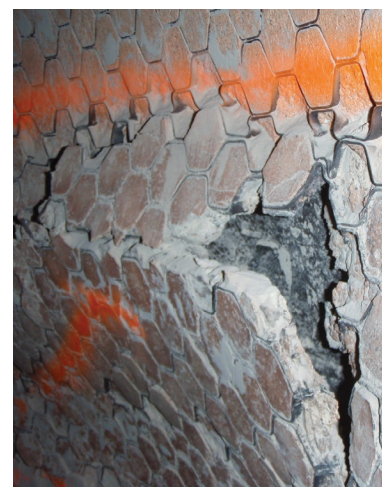
Sheet Spalling

When welds fail due to bypass and stress cracking, sheets of hex will break and spall.

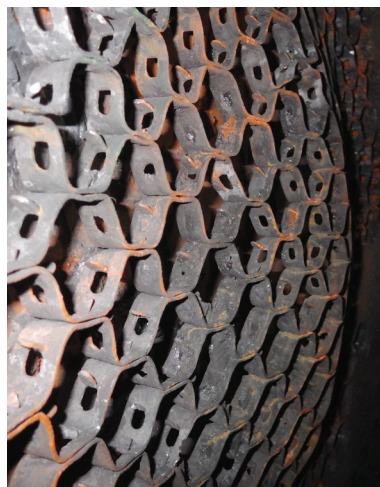
Bulging is caused by inherent stresses in hex, and causes localized hotspots and turbulence.

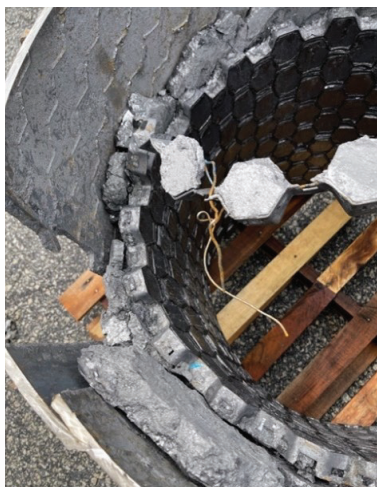
Coke Jacking

Once coke gets behind and builds up, it forces the lining away from the wall.

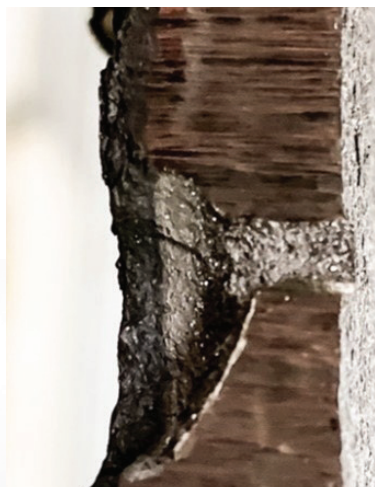
Carburization

Exposure to bypassed gases will cause carburization and lead to structural degradation.

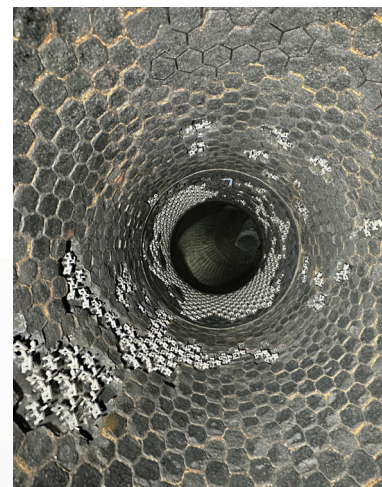
Poor Repairability

Hex metal is notoriously hard to repair and allows for a heavily contaminated shell surface.

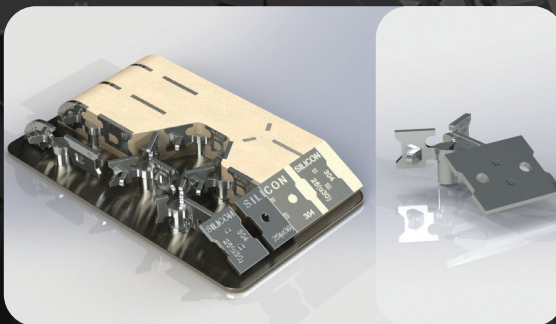
SpeedHex Refractory Termination

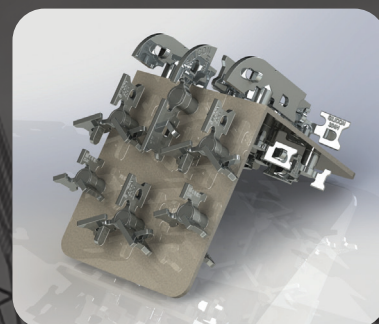
SpeedTab® on 90° Corners

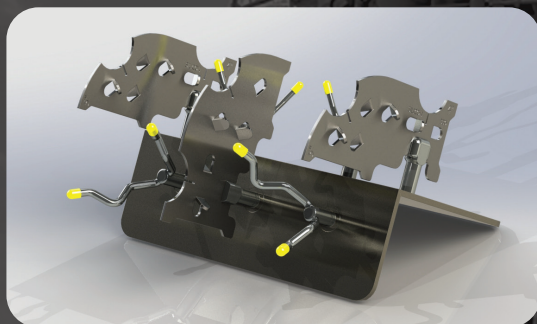
SpeedVee® & SpeedTab Mega on Corners

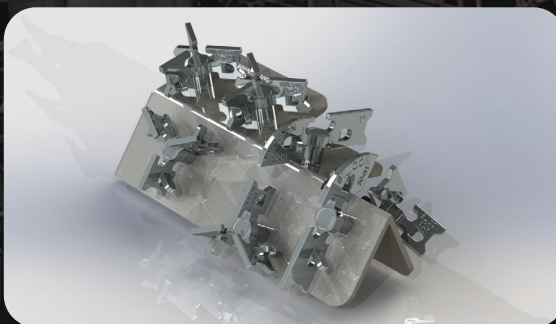
SpeedTab & SpeedHex on Varying Bullnose

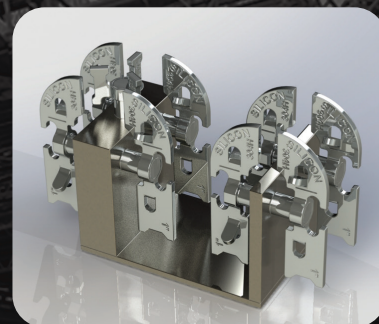
SpeedTab on Pipe Edges
