MITIGATING FAILURES OF ABRASION RESISTANT REFRACTORY LININGS

This whitepaper addresses a critical design flaw in abrasion-resistant refractory linings, which allows refractory lining bypass to occur. It explores the causes and consequences of bypass, examines the behavior of conventional closed and non-closed cell anchoring systems in both coking and non-coking environments and introduces an alternative anchoring solution.

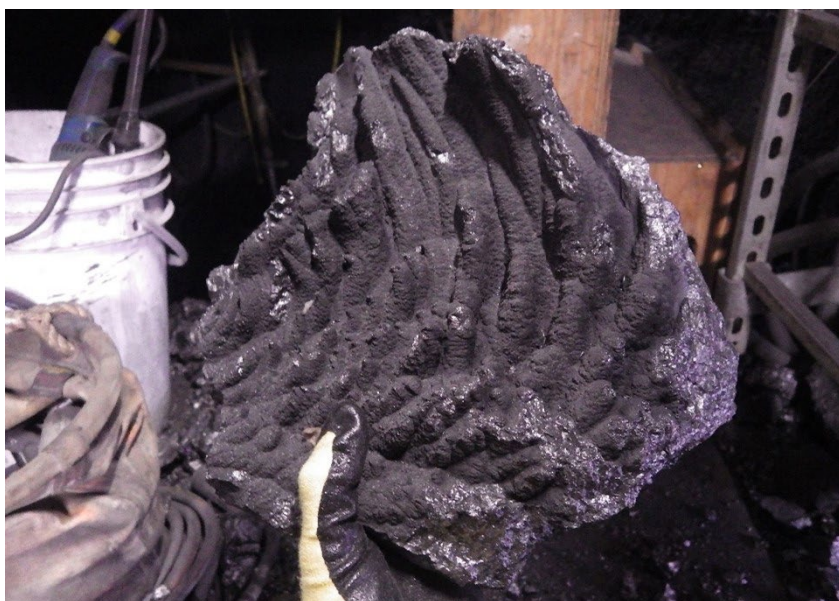
An example of built-up cokes formation.

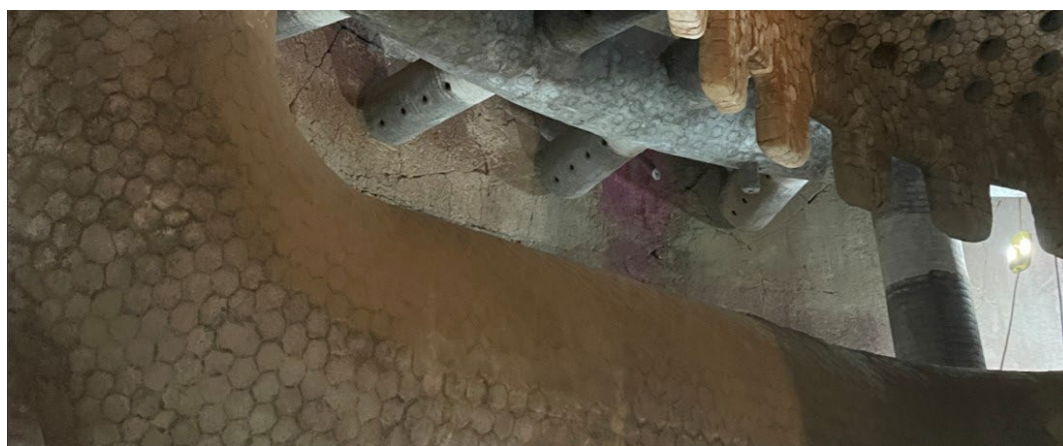
Thick layers of catalyst dust can be found in the regenerator, non-coking environments.

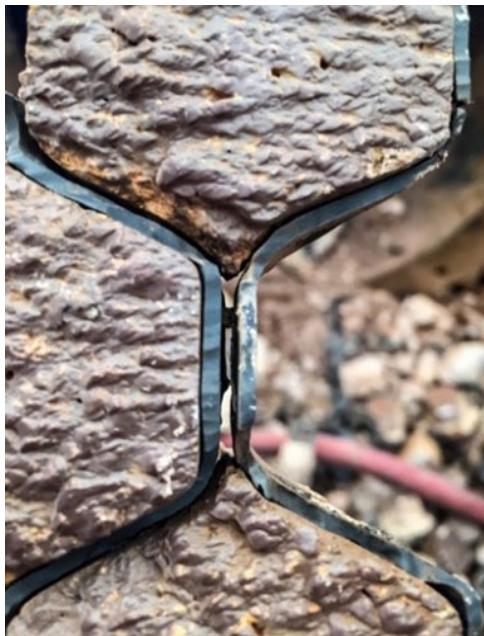
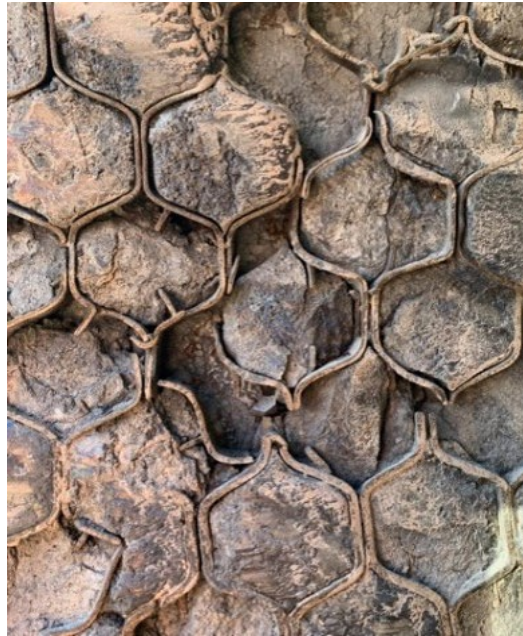
Despite the closed cell system being the most used and recognized anchoring system, its design allows for various pathways that bypass the protective lining within the cell. A key weakness of a closed cell system is the presence of gaps between clinches of connected metal sheets. Additionally, shrinkage of the refractory during dry-out may also create small gaps between the steel and the refractory. These gaps allow gases, catalysts, and various processing elements to flow behind the lining, settle and build up over time – directly affecting not only the anchor system but also the shell and the lining's overall effectiveness.

Inherent in its design, closed cell systems allow for pathways that reach behind the lining.

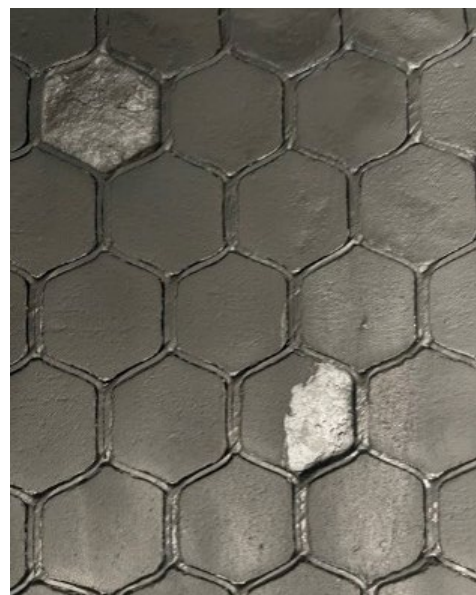
In coking environments, a notable difference compared to non-coking environments is the black discoloration of refractory material. The porous nature of refractory exposes it to carbon-containing gases, liquids, and solids present, leading to product absorption. This absorption causes refractory cells to slightly expand, contributing to coke jacking – an added stress on welded metal due to a leveraging effect away from the shell. While expanding refractory cells are a factor, a more significant stress contributor in coke jacking results from coke buildup behind the lining, facilitated by bypass.

Refractory after coke absorption.

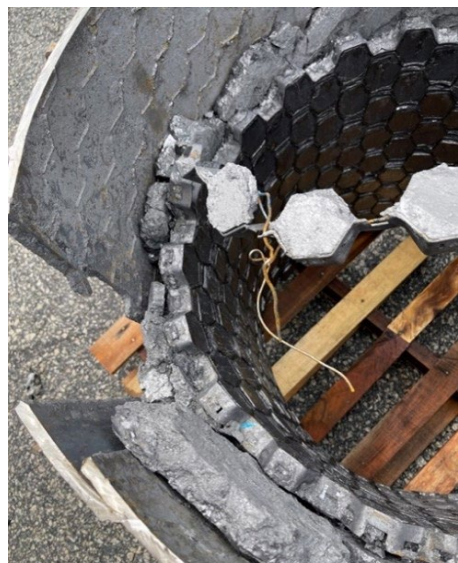
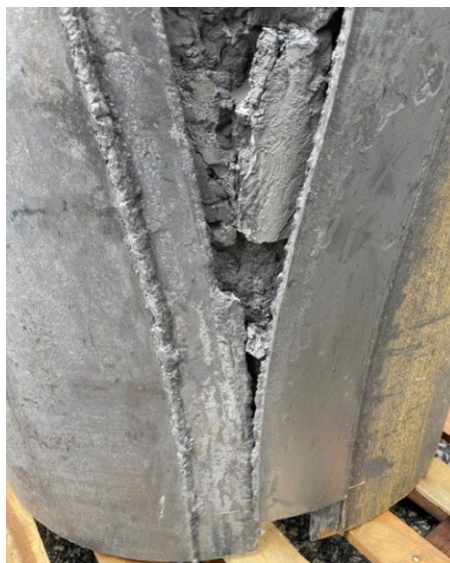
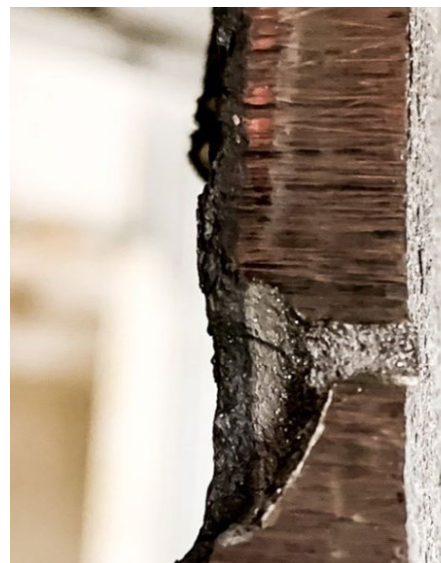
Case Study: FCC Reactor Cyclone - Closed Cell System

Liquid bypass has caused a coke build-up so significant that the continued formation and expansion of this build-up not only caused coke-jacking to separate the hex metal from its welded interface, but also caused numerous components to crack along

Left/Middle: A Reactor cyclone dipleg that required replacement within 3 years of operation due to bypassed refractory lining. Right: Carburized steel shell of at least 6mm after prolonged exposure to bypass.

From the observations, it is evident that bypass was at the root of the thick build-up behind the lining:

- 1) Bypass allowed continued coke formation behind the lining.
- 2) Due to exposure of the coke-forming elements, stress corrosion cracking occurred in sensitized hex metal.²
- 3) The shell was exposed to sulfidation and carburization, weakening its structural integrity.
- 4) Coke jacking caused a large portion of the anchoring system to be separated from the shell, while the shell itself ruptured.
- 5) The failure was sufficiently large that a complete blockage was observed. This warranted an emergency shutdown.

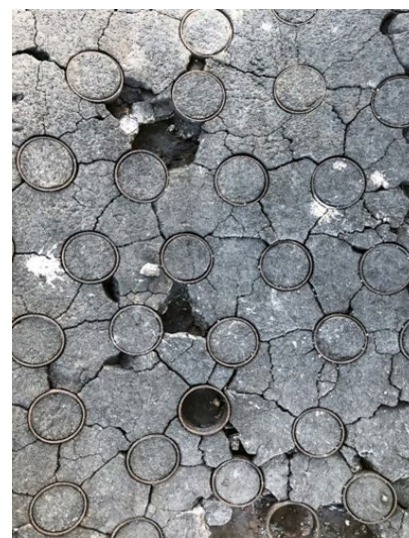
Non-closed systems aim to achieve a monolithic lining, often at the expense of refractory retention in the event of cracking. Coking in these linings is concerning, as the absorbed coke exerts additional forces on the refractory. This process causes unpredictable crack formation, leading to more bypass. Due to the absence of an interconnected mesh, refractory material may completely dislodge, causing isolated hotspots and corrosion.

- 1) Uncontrolled cracking observed through thermal cycling, coke absorption and no crack propagation barriers. From this point, bypass mechanisms start to occur.
- 2) Bypass causes cokes to continue building up behind the lining. Coke jacking of refractory causes chunks of refractory to potentially separate from the shell and other refractory.
- 3) Fully exposed steel will experience hot spots and may require steam cooling.
- 4) Due to fully exposed steel, corrosion may occur faster leading to emergency leaks and patch repairs or shutdowns.

Refractory with missing chunks.

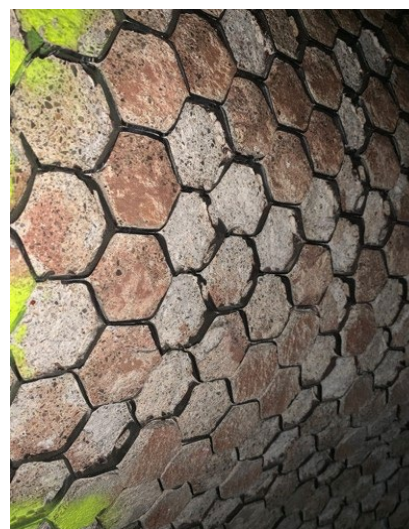
Another notable observation which occurs mostly in non-coking environments, is the separation of hot-face facing portions of refractory cells, resembling laminated refractory. This phenomenon is called biscuiting due to its resemblance to biscuits.

Refractory spalling, called biscuiting.

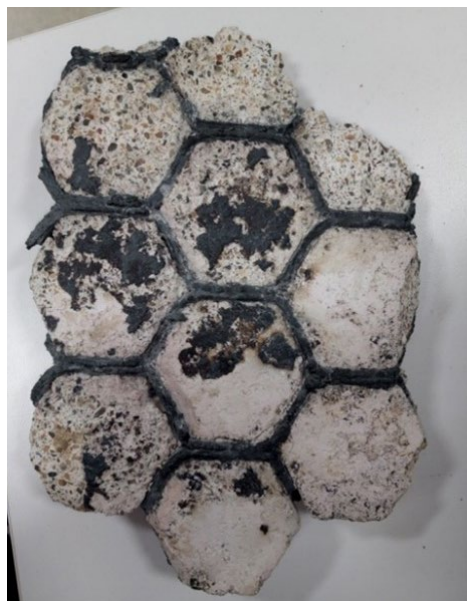
Gas bypass in a low-oxygen processing environment can cause rapid deterioration of hex metal and its weld interface to the shell, as seen in this case study. In addition, this regenerator cyclone suffered damage in various locations on the shell due to carburization, manifesting as small pitting marks. Heavy catalyst loss was also experienced. An emergency shutdown was necessary, requiring both shell repairs and full replacement of the lining.

Backside of Regen Cyclone Hex

It was notable that the backside of the lining was more affected than the front. This failure could not have occurred without bypass.

- 1) Carburizing and sulfidizing elements, as well as catalysts, build up behind the lining and deteriorate the anchoring system and shell.
- 2) Sensitization of steel occurs, leading to a domino effect of hex metal and its welded joints to the shell being deteriorated until the point of separation from the shell.
- 3) Refractory as well as partial hex metal starts spalling, peeling and biscuiting.
- 4) Hex metal sheets separate from the shell, leaving the shell exposed. At this point, an excess of 50 tons of catalyst loss was experienced daily.
- 5) The absence of vessel protection led to damage to both the vessel and its supports. A catastrophe was averted by initiating an emergency shutdown.

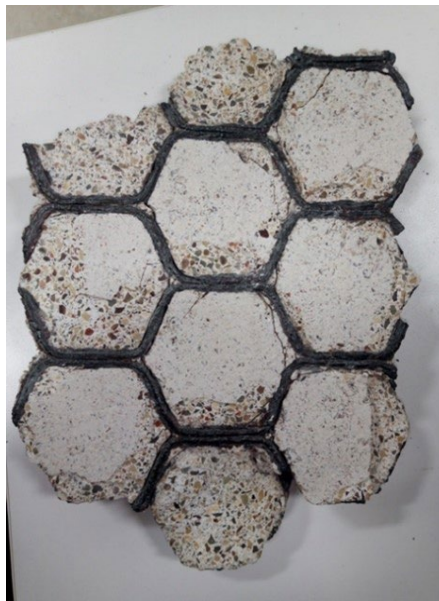
Frontside of Regen Cyclone Hex

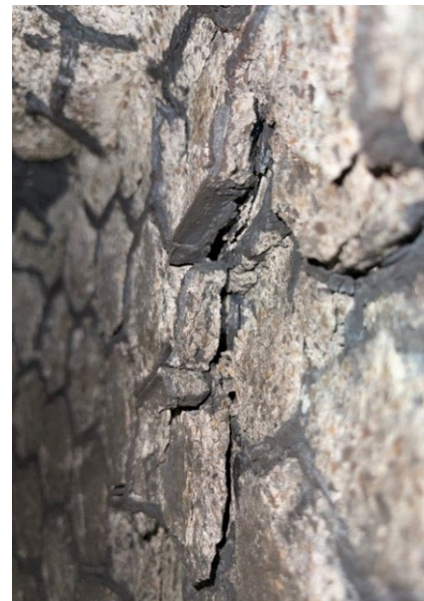
Biscuiting & Hex Spalling

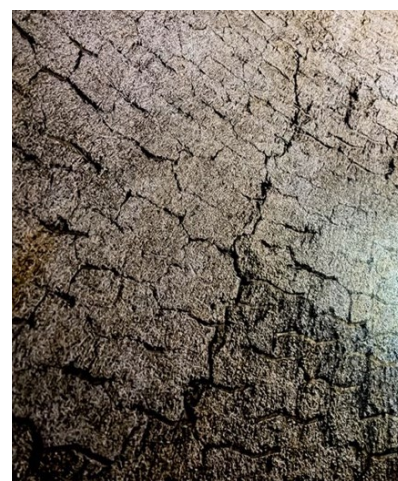
The image on the right displays a riser lining where most of the smaller cracks did not propagate further. However, with the large runaway cracks, warping of the steel shell was experienced. Fortunately, no catastrophic incident occurred, but the riser lining required almost 30% replacement of its refractory and anchoring. Once again, refractory bypass was the underlying cause of the repair needs.

Runaway cracking in refractory.

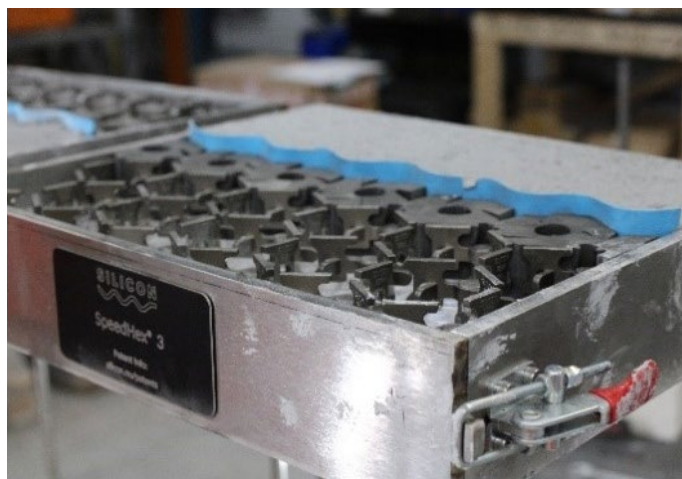
Sample panels with semi-closed and closed anchoring systems, incorporating various types of industry-standard refractories, were utilized. Panels with the semi-closed cell system had its refractory material installed in two phases—half of the panel received refractory installation, was terminated with refractory backing clips, underwent a complete dry-out cycle lasting approximately 24 hours, and then the remaining refractory was installed in the other half. This deliberate process was employed to purposely create a cold joint. Panels with the closed cell system were also installed in two phases, with the hex cell in this case forming a hard barrier for installation of the other half of refractory. After the dry-out cycles were completed, 1 liter of ink-colored water was poured over each sample panel, after which it was observed for 10 minutes.

Semi-closed cell system refractory installation with an intentional cold joint.

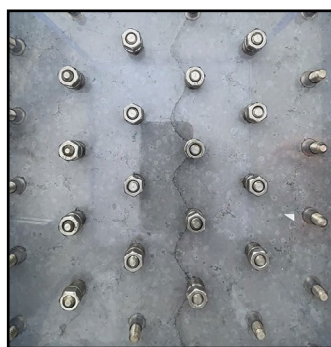
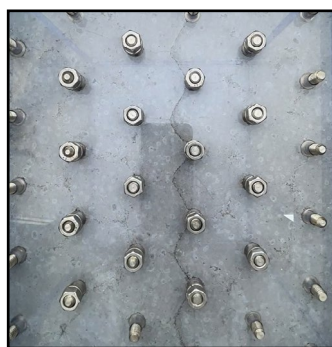
Sample Type: Semi-Closed Cell System

Minor absorption of the test fluid through and reaching behind the refractory lining was observed. No penetration or lining bypass was observed within the cells or at the cold joint after 10 minutes.

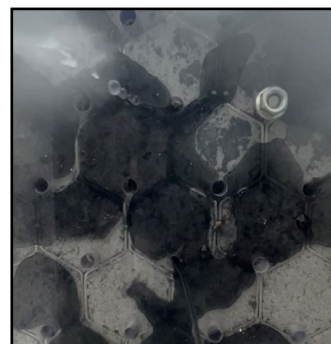
Sample Type: Closed Cell System

Penetration or lining bypass was observed within seconds in the cells and at metal joints with all test fluid flowing through. This may be attributed to cold joints formed between the refractory material and the closed cell anchoring system as well as occasional gaps at the metal joints. The tests concluded within approximately 90 seconds, as the test fluid had fully penetrated the lining by that time.

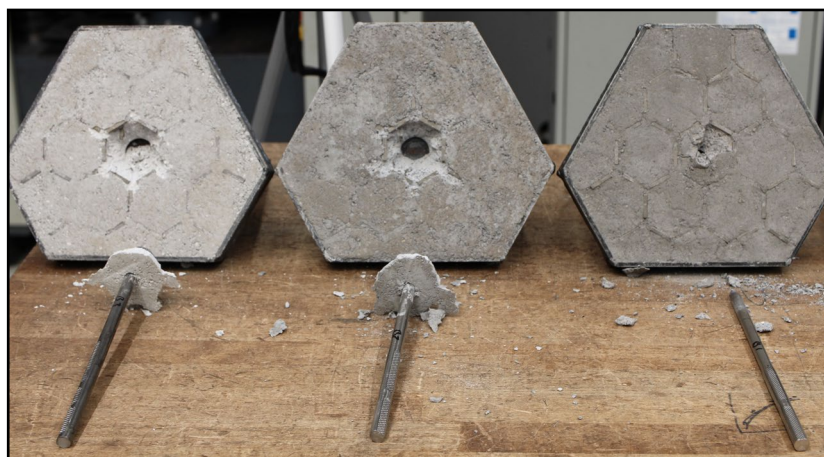
Sample Type: Semi-Closed Cell System, After Pull Test

On average, approximately 42.9 kN of force was required to pull out a cookie.

The pull test results revealed that the semi-closed cell system showed a significant difference to the closed cell system in retaining abrasion-resistant refractory material. This is attributed to the design of the semi-closed cell system, with embedded anchors in a monolithic refractory lining providing robust support and resistance against forces that could cause refractory separation from the anchoring. Refer to the illustration below for a visual representation of these forces in both systems.

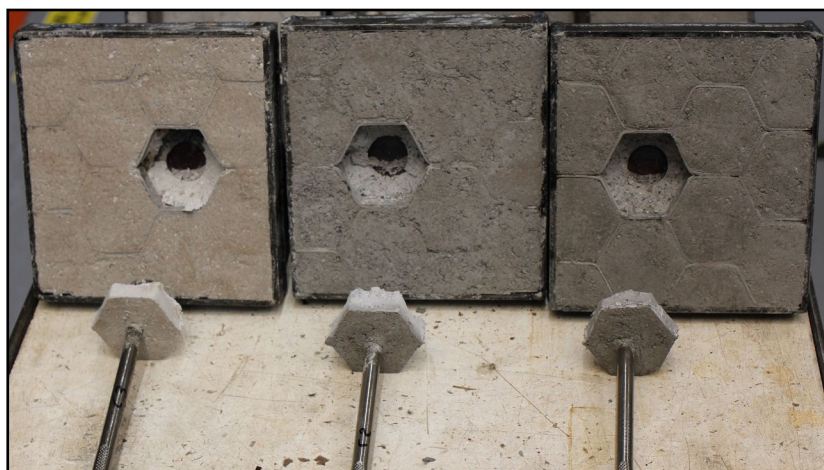
Sample Type: Closed Cell System, After Pull Test

On average, approximately 7.6 kN of force was required to pull out a cookie.
